AN ASSESSMENT OF THE PERFORMANCE AND RELIABILITY OF OLDER ERW PIPELINES

**R. J. Fields
E. N. Pugh
D. T. Read
J. H. Smith**

**U.S. DEPARTMENT OF COMMERCE
National Institute of Standards
and Technology
Institute for Materials Science
and Engineering
Gaithersburg, MD 20899**

Issued July 1989

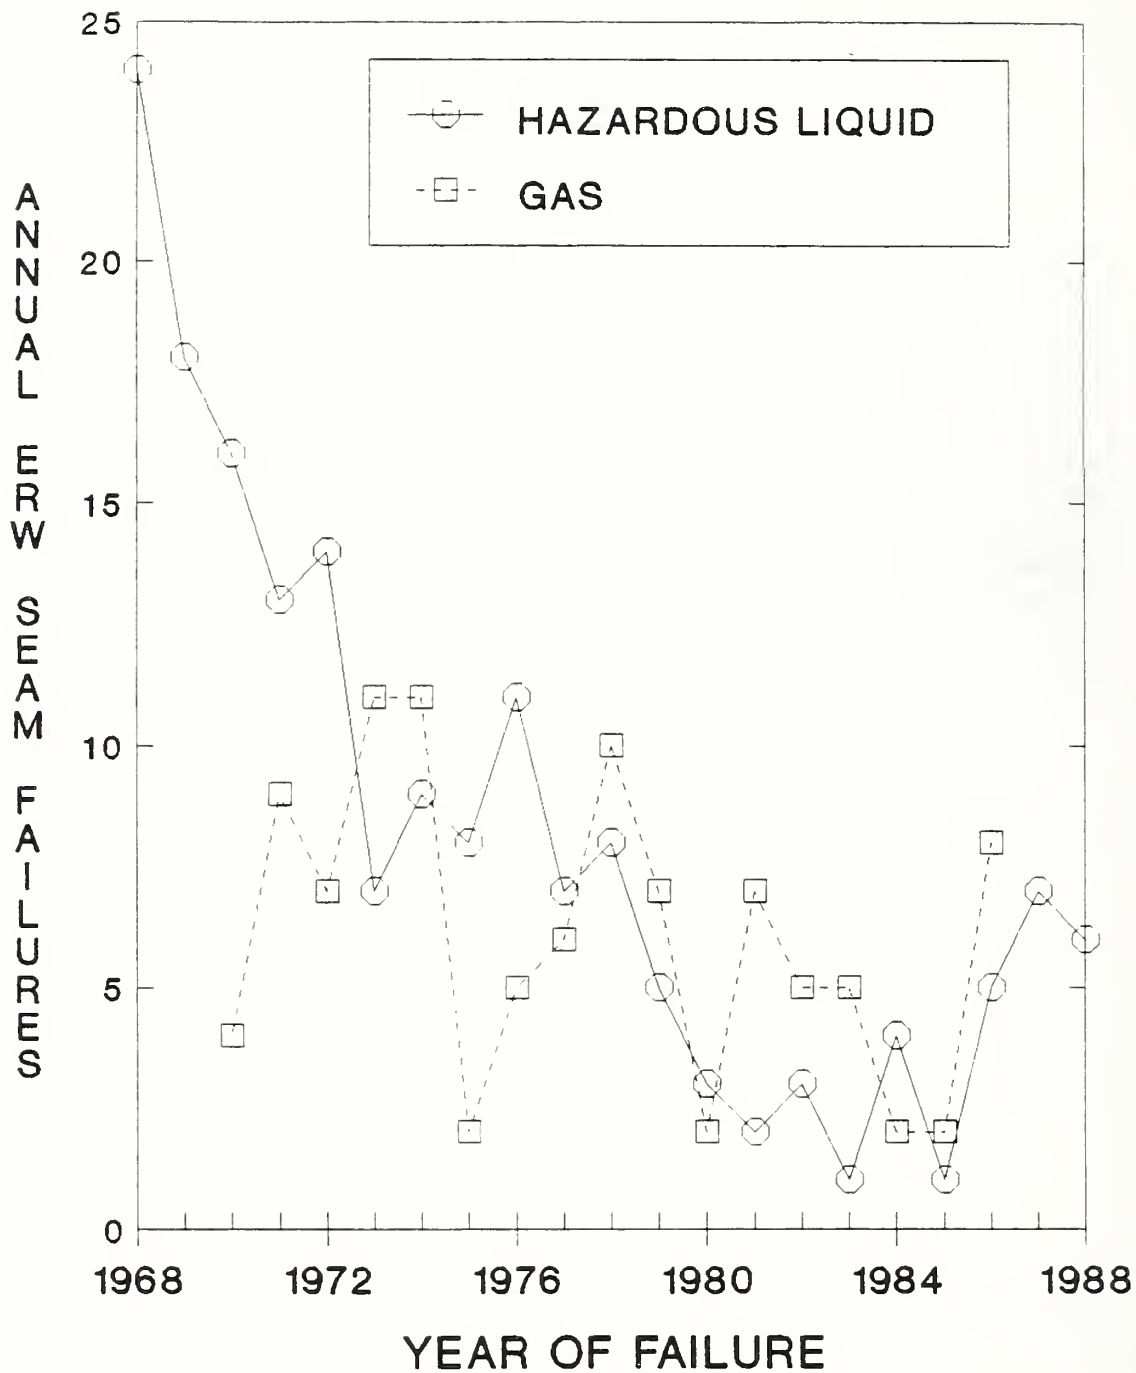
The data do not allow strict statistical analysis, but the values for HL, Table 4, indicate that the total number of failures per year was initially large and then decreased to an approximately constant value of about 5 failures per year. This trend is shown graphically in Figure 1. This effect is not evident for NG, Table 5 and Figure 1, where the total number of failures per year fluctuates about an average value of about 6 failures per year. The reason for the initially decreasing trend for HL pipelines over the period 1968 to 1978 is not known.

Figure 1. Annual Number of ERW Seam Failures in Hazardous Liquid Transmission Lines and Natural Gas Gathering and Transmission Lines During the Period 1968-1988 (15).

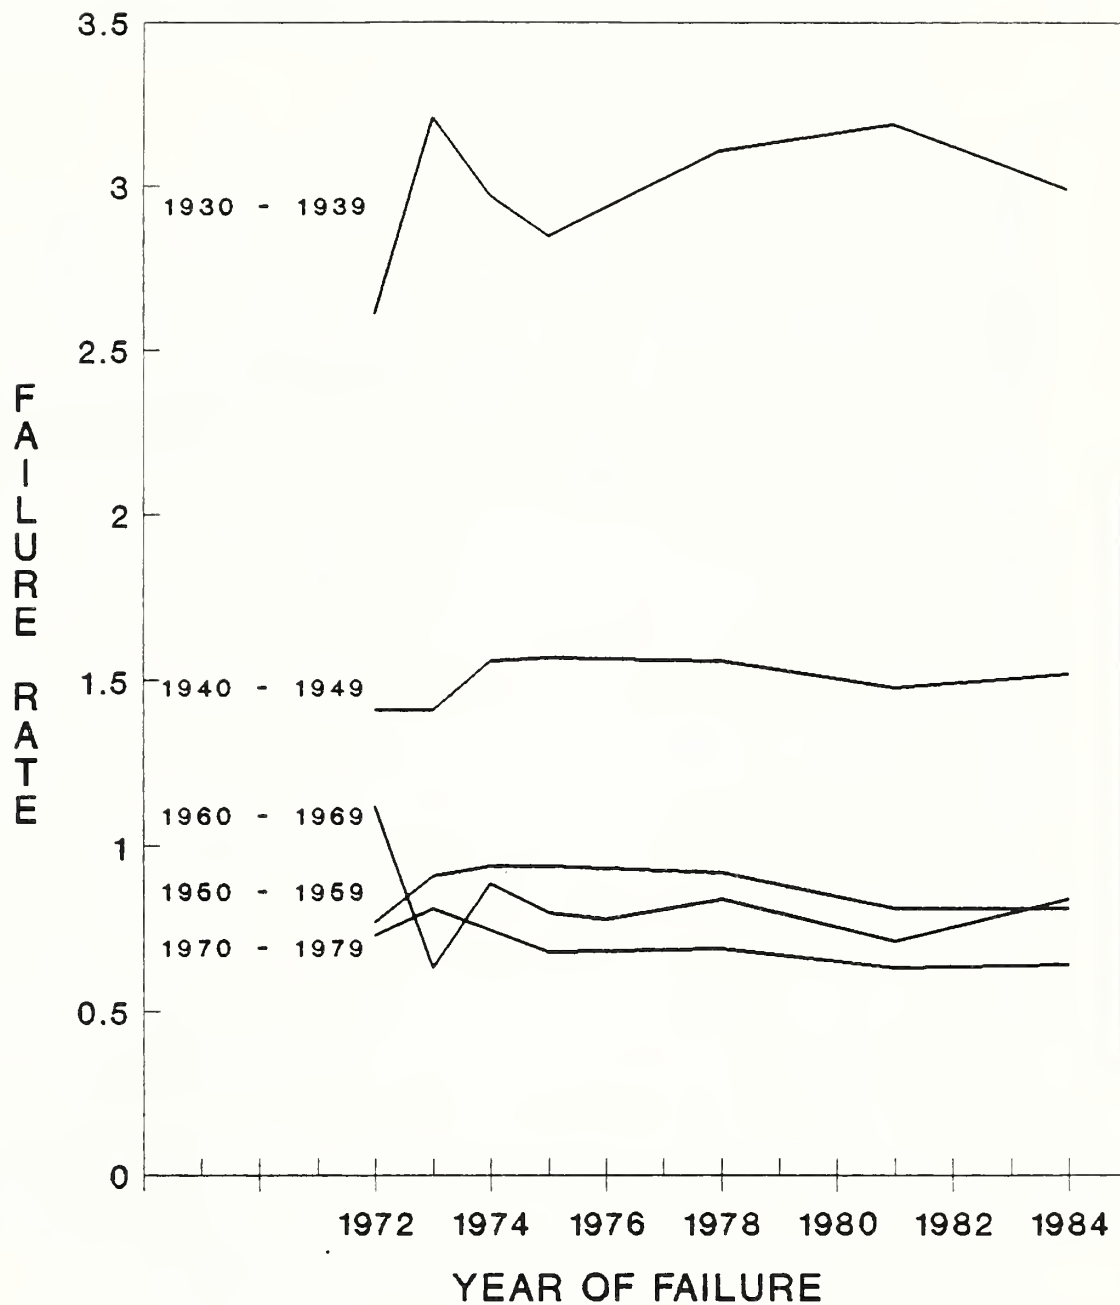
The Battelle report on NG pipelines (16) used mileage data similar to those of Table 3 to determine failure rate as a function of construction decade and incident year. Their findings, summarized graphically in Figure 2, show two important points:

- (1) Pipelines constructed in the 1930s and 1940s have significantly higher failure rates than those installed in the 1950s, 1960s and 1970s, the latter showing little differences. The fact that these older pipes show larger failure rates is worthy of attention, but is offset by the relatively small mileage installed in these decades, Table 3, and by the fact that many are being replaced (19).
- (2) As in the case of ERW seam failures, Section 4.2.3, it is somewhat surprising that the failure rate in the period 1970-1984 is essentially constant with incident year for each of the five decades represented in Figure 2. There is no evidence for an aging effect in these data.

Figure 2. Annual Rates of Failure (number per year per 1000 miles of pipeline) in Natural Gas Gathering and Transmission Pipelines for the Period 1970-1984 Classified by Decade of Construction (16).

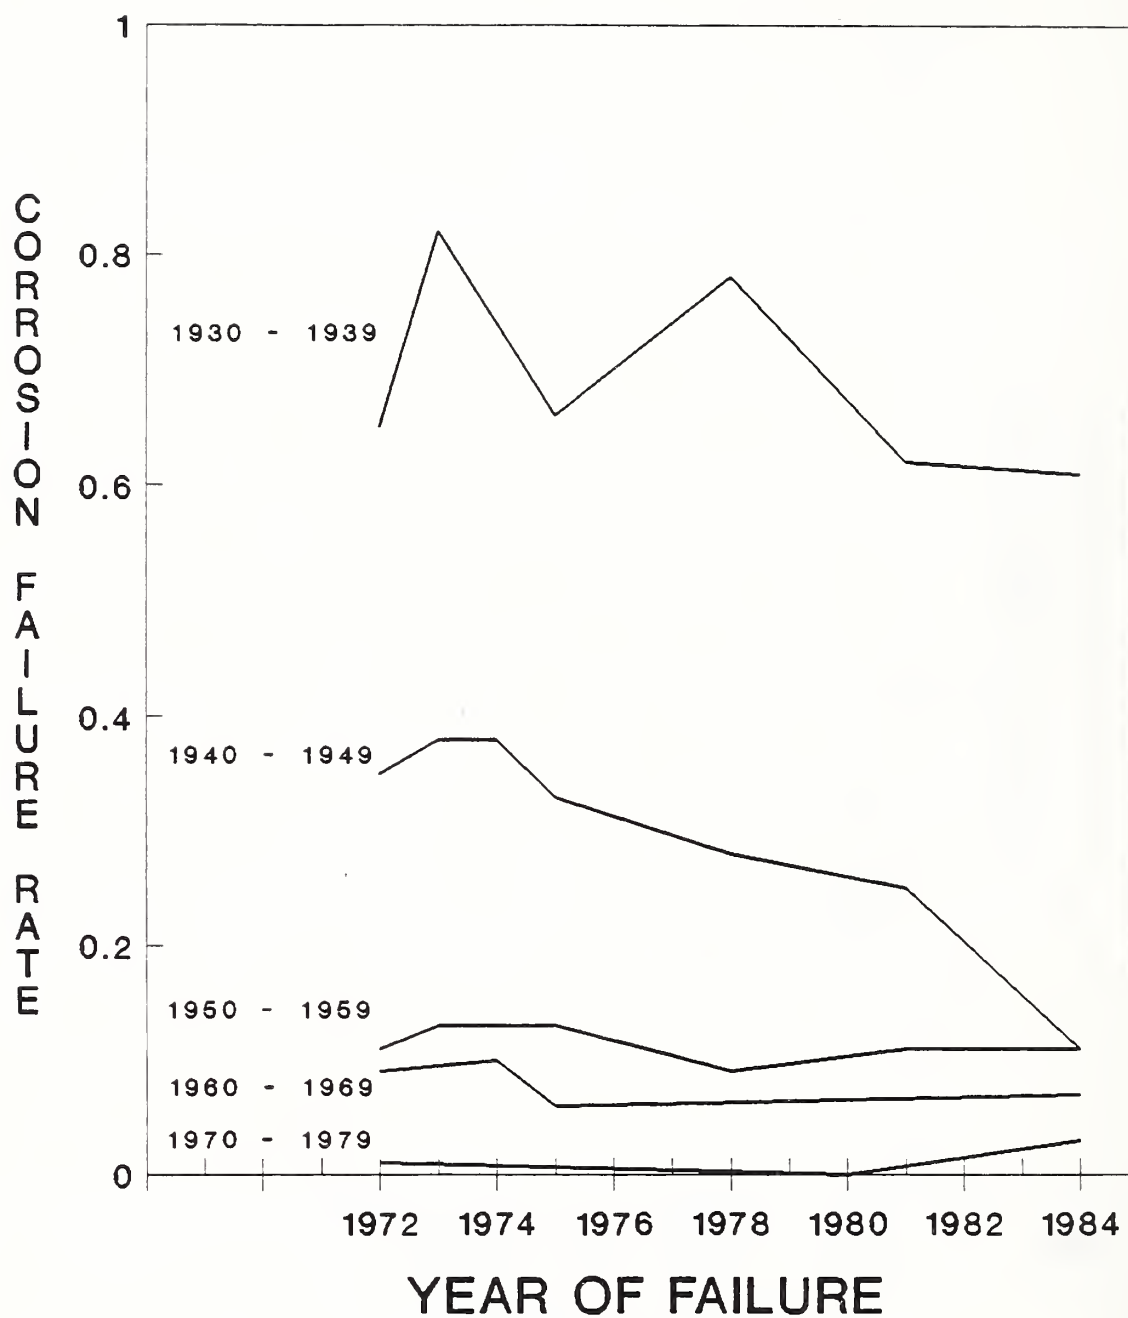
Corrosion can be seen to have represented a major cause of failures in NG, Table 7, and HL, Table 8. In addition to the relatively small number of failures resulting from preferential attack at ERW seam welds, it is assumed that these failures stem from wall thinning due to uniform corrosion, and perforation due to localized forms such as pitting, stress corrosion cracking and hydrogen embrittlement (17). However, continued improvements have been made in corrosion protection over the past decade, including the mandatory use of coatings and cathodic protection, and there is evidence in the Battelle study (16) that these measures are having a major beneficial effect. Thus, Figure 3, taken from that report, demonstrates that the rates of failure due to corrosion have decreased markedly over the decades from 1930-1979, and that the rate for the 1970s is very small. Moreover, the failure rate for each decade shows no significant increase with time, again indicating that no aging effects are discernible.

These data suggest that the corrosion problem in pipelines, in general, is being effectively combatted. However, it can be seen in Figure 3 that, with the exception of the 1940s, there is no evidence that the failure rate in each decade is decreasing with time. This would suggest that the most current methods of protection and monitoring are not being effectively retrofitted, despite the regulatory requirements (20,21). Thus, as the Transportation Research Board report (18) emphasized, there is a need to sustain and extend our advances in corrosion control. This has particular relevance to older ERW pipe, as indicated in Section 5.0.

Figure 3. Annual Rates of Corrosion Failures (number per year per 1000 miles of pipeline) in Natural Gas Gathering and Transmission Lines for the Period 1970-1984 Classified by Decade of Construction (16).
